Product Thermal Performance

R&D tests were conducted to evaluate a series of product developments aimed at extending system capabilities to meet increasingly stringent requirements for thermal transmittance and condensation resistance. Specifically the use of composite materials, insulating coatings and various forms of weather sealing were evaluated against a product baseline to determine the merit of each application. Results were used to bench mark computer simulated results and to extend the scope of the analysis by further simulation of untested configurations.

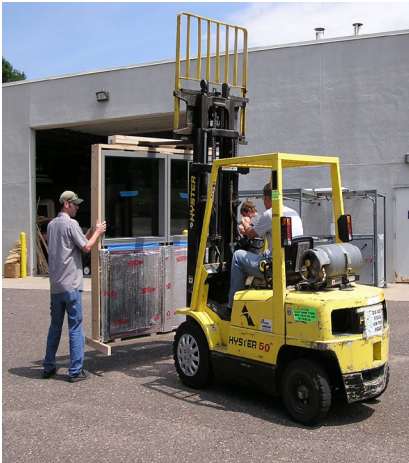
Figure 1b. Mock-up of test specimen.
